DCN Next Generation 4.41 Release Notes

DCN Next Generation Release 4.41

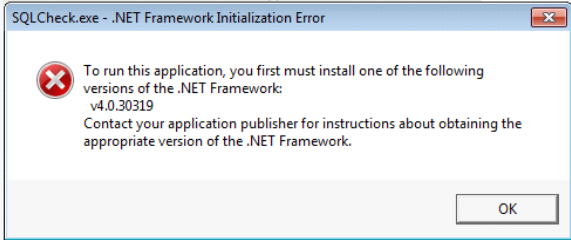
Reference	What
DCN-SW	<p>When installing DCN-SW on a Windows 7 PC you might get the following notification:</p>

<p>This is because within the time installer checks for framework, SQLServer installation starts which prompt for the framework installation. Please press OK, after this the framework will be installed from the DCN-SW installer and DCN-SW installation will install successful.</p>
Wireless Discussion Units	Wireless Discussion Units which are produced before 2012 need to be upgraded using the DCN-UPTK and DLT (4.xx) in order to operate with a DCN-CCU2.
DCN-SWSMV	<p>Showing voting results in PowerPoint</p> <p>In case PowerPoint is used to show the voting result, it might happen that PowerPoint starts and overlaps the user interface of DCN-SWSMV completely. Use the Windows task bar to select DCN-SWSMV again.</p>
DCN-SWSMV	<p>Printing voting results</p> <p>To print voting results, Crystal Reports needs to be installed. It is located in the Tools directory of the DVD.</p>
